LANDSLIDES AND RELATED FEATURES

OF THE LOIS, TENN. QUADRANGLE

1982

U.S. Geological Survey
Open File Map 82-750 (B-14)

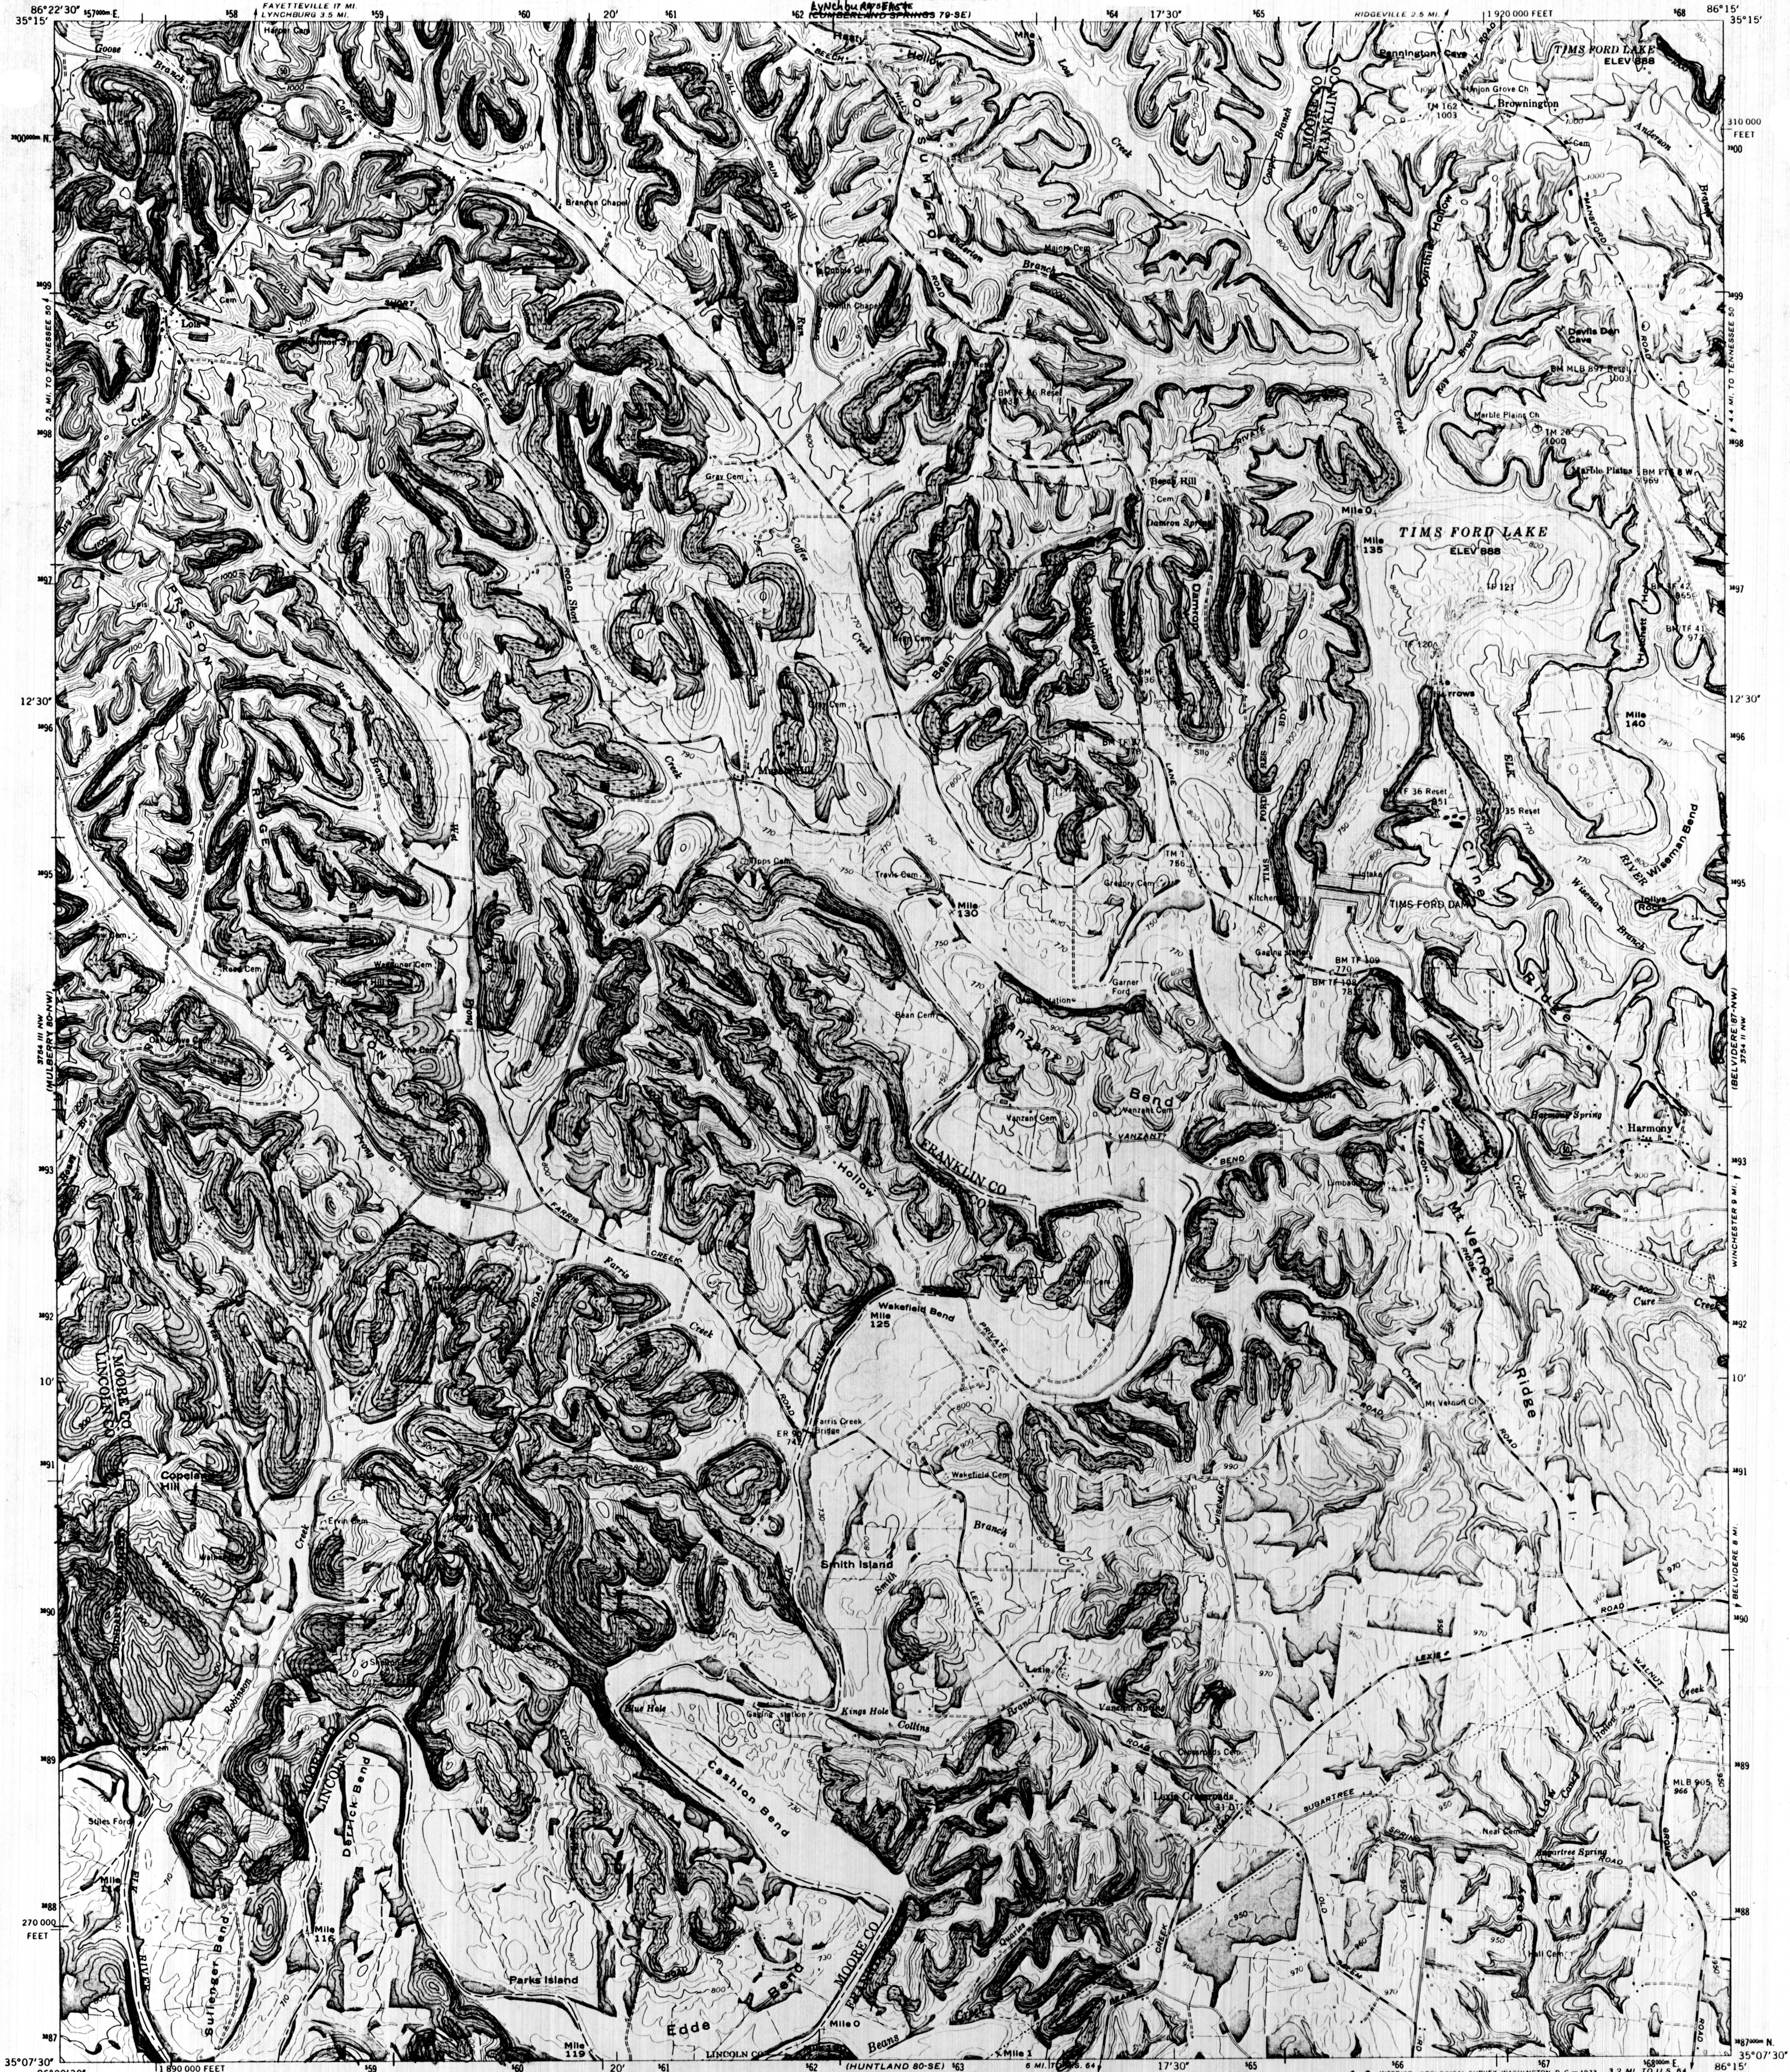
LOIS, TENN.
N3507.5-W8615/7.5

Landslides and related features interpreted
from aerial photographs:

- ACTIVE OR RECENTLY ACTIVE LANDSLIDE**
Complex landslide composed of earthflow, debris slide, earth and rock slump. Identified from historical records, and from scars, debris and other field evidence. Ground extremely unstable; sliding accelerated by excavation, loading and changes in drainage conditions. May include areas with several active slides too small to be shown separately. Questioned where doubtful.

- OLD LANDSLIDE**
Area of extensive hummocky ground caused by earthflow and earth and rock slump. Lacks clear evidence of active sliding. Relatively stable in natural, undisturbed state, generally not affected by small structures properly sited in areas away from the edge of the toe; can be reactivated by extensive, rapid excavation, loading, and changes in ground water and surface water conditions. Area of old landslide probably includes recent ones not identified from field evidence or otherwise documented. Upslope boundary of landslide generally defined by modified scarp, but downslope (toe) may be gradational and not well defined. Questioned where doubtful.

- COMBINATION LANDSLIDE**
Area of recent and old slides in which individual slides are not identified.
- COLLUVIAL SLOPE**
Valley wall along major streams with slope as steep as 40° (85%); stony, clayey silt soil up to 50 ft. (15 m) thick; commonly buttressed by a terrace or bench at the toe of the slope; very susceptible to sliding by cutting of toe area, removal of terrace or bench, and overloading; slide commonly activated without apparent cause.

- COLLUVIAL SLOPES WITH LANDSLIDES**
Landslides too small or obscure to map individually.
- AREAS SUSCEPTIBLE TO DEBRIS FLOWS AND DEBRIS AVALANCHES**
Primarily shallow, narrow ravines and chutes with accumulation of stony colluvium generally 10 ft. (3 m) or less in thickness; susceptible to rapid movement during intense rainfall. Most ravines and chutes designated show evidence of former debris flows and avalanches.

- AREAS SUSCEPTIBLE TO ROCKFALL**
Steep, locally vertical, natural and man-made slopes and cliffs, 15 ft. (4.5 m) or more high; formed dominantly of sandstone, limestone, sandy shale, mudstone and claystone. Interbedded mudstone, claystone and shale weather rapidly leaving sandstone and limestone rock faces unsupported.

- SOIL AND ROCK SUSCEPTIBLE TO LANDSLIDING**
Soil and rock similar to that involved in landslides elsewhere in map area; primarily areas underlain by claystone, mudstone and shale associated with other rock types. Rock weathers rapidly on exposure forming clayey soil highly susceptible to sliding. Includes coves (U-shaped, shallow valleys) containing thick layers of clayey soil that are very susceptible to sliding where excavation breaks continuity of slope and where overloaded by artificial fill.

AREAS LEAST PRONE TO LANDSLIDES
Map areas in which no patterns or symbols are shown; primarily valley floors, ridge tops and broad benches; modification by excavation and fill may lead to local landslides.

NOTE
Information shown is intended as a general guide to ground conditions as of the date of field check. Additional landslides and rockfalls should be anticipated in all map units. The map unit depicts the dominant condition in the area delineated and variations in slope stability may occur at any point in the unit. This map is suitable for general planning purposes and as a supplement to more detailed studies for site selection. The map cannot be used as a substitute for detailed geologic and engineering investigations to establish design and construction criteria of specific sites. Some symbols may not appear on this map because the description is applicable to a series of maps.

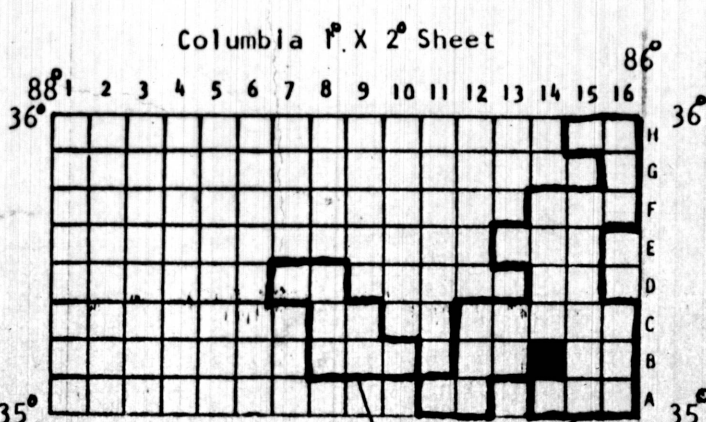
The first five digits of the open file number designate the specific 1:250,000 scale map sheet of which this quadrangle is a part. The last two digits designate the position of the quadrangle in a subdivision of the 1:250,000 scale map based on rows and tiers shown in the diagram to the right. The location of this quadrangle is shown by the black square.
